Exhibit A

The following comments are in order according to the 5/14/12 Cost Estimate spreadsheet Item#

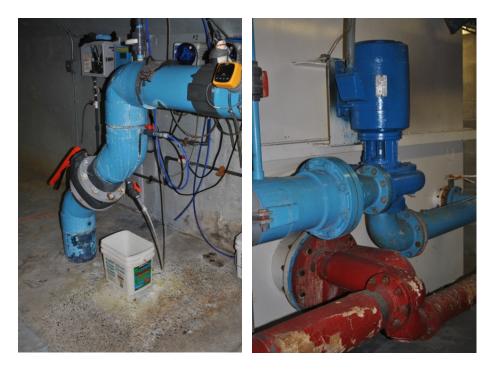
2. Replace the pool water recirculation pump with a Variable Frequency Drive (VFD) pump/motor, the existing one is original and costly to maintain (a couple thousand every year approx.). The threaded holes in the volute are wearing out so we are very limited in the amount of times we can rebuild this pump before it fails completely. It is a necessary replacement. Also, a new VFD will be more energy efficient and allow the pump to increase flow to compensate for increasing filter pressure thus maintaining better filtration potential.

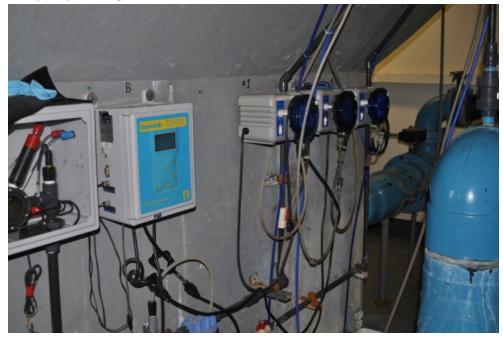
4. Replace Chemtrol with new chemical feeding system (probably BECS). Plumb new system into the new pool plumbing too.

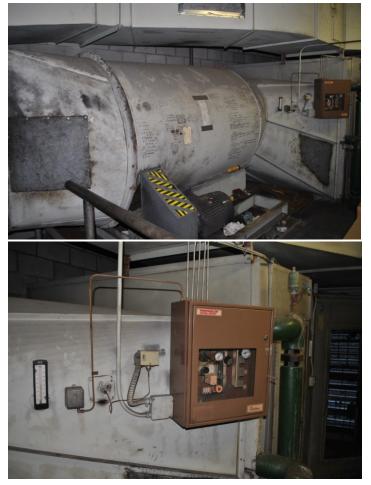
5. Provide DDC controls upgrades, control damper repairs, and retro-commissioning services to the natatorium and locker room air handling units. The fan and motor will be replaced on the natatorium air handling unit. Existing HVAC area will be used and new parts will be brought in through the existing north wall air intake New controls will provide the ability to actually control the air temperature and humidity thus providing greatly improved energy efficiency.

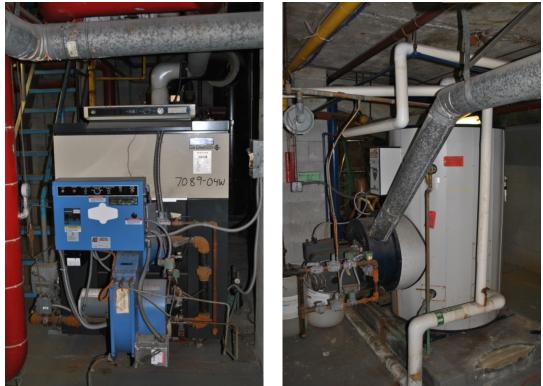
7. Utilize existing boiler but replace the burner with new higher efficiency burner and new controls and safety checks. Work on improving the turn down so the system uses less gas.

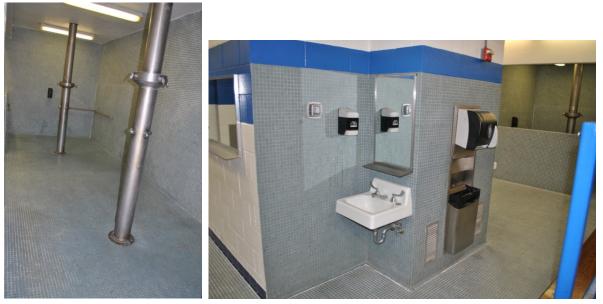
10. Remove existing locker room shower wall tiling and replace with Fiber Reinforced Plastic (FRP) panels that are very low maintenance and mold/mildew resistant. FRP is less expensive than new tile.

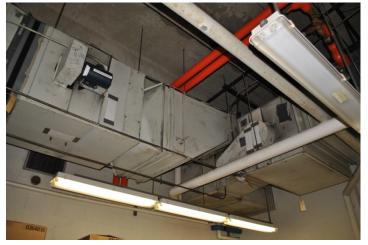
11. Replace existing lobby HVAC supply fan motor.

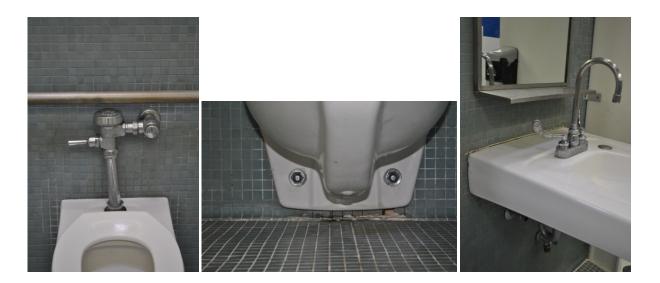
- 12. Replace existing lobby HVAC exhaust fan motor.
- 13. Replace all china (except urinals) and plumbing from wall shut-offs to fixtures. Many of existing shut-offs do not work and cause the need to shut-off water to the entire locker rooms to make a repair. Staff are constantly repairing leaks. All new fixtures will be low flow water saving fixtures. This item can be modified to do no china (fixtures) just plumbing for a reduced cost. New shower trees and improved control over the shower temps will be achieved through this item.

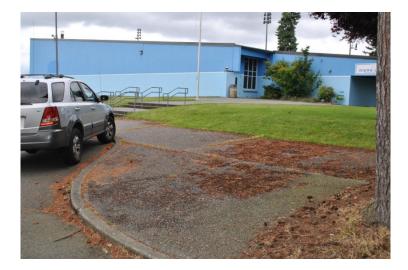
- 17. Different options are being looked at to complete this in the most cost-effective and efficient way. Includes removing some of the existing concrete panels near the parking lot, adding a ramp and landscaping to blend it all in. The issue with this is the slope of parking lot at the stalls where this would be installed (closest stalls to front doors). If this project is done then it has to be brought up to code and that will require leveling the parking stalls approximately 8 inches. Different options are being looked at how to achieve this in the most cost effective way.

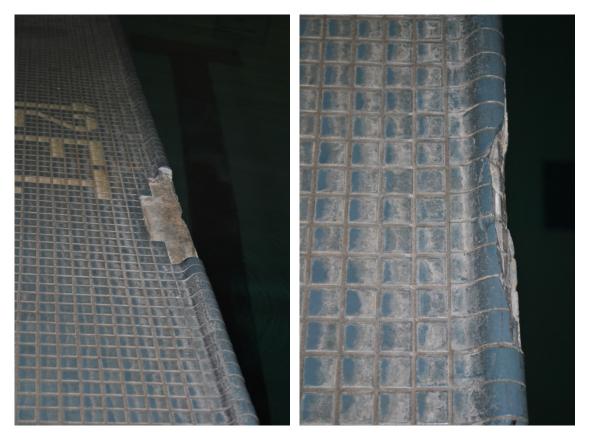
19. This scope can be reduced if necessary to only repairing the broken tiles on the deck (bullnose) and cleaning the existing or could entail replacing the bullnose completely, new face tiles with depth markings, and a new bullnose edge tile then cleaning the flat tile on the deck. This item, if done in the entirety, would have a nice improved look to it and not look like patch work.

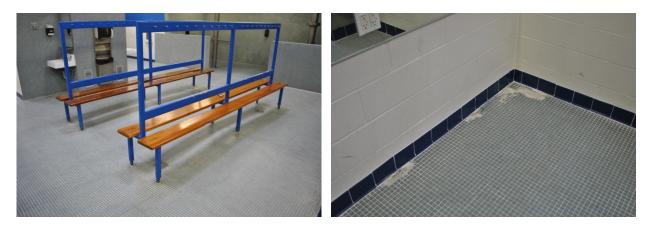
- 23. Staff can purchase and install this unit. It will bolt into place where the previous deep end guard chair had been.
- 24. The goal of providing a private dressing area can be achieved by installing a partition wall and door in the corner of the locker room and adding a bench and a hook. The material could be virtually maintenance free and graffiti resistant if it were similar to the toilet partitions in there now.
- 25. This is a mortar floor that would provide a slip resistant surface, look nice, provide for better and safer maintenance, and would match the new deck (and lobby?) flooring if those items are done.

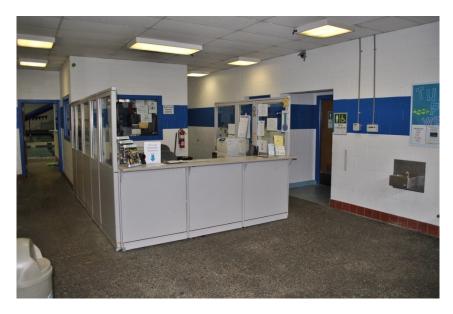
29. The reception desk can be reduced in size to make room for another office and possibly could be relocated to the corner of the lobby too for a new entrance feel.

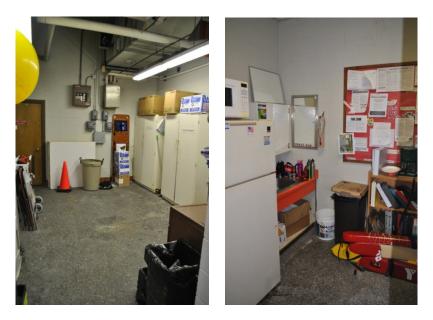
32. Providing a new designated staff room (relocating it to the current supply room) will allow staff to keep personal belongings out of the lobby reception area therefore keeping the front entrance neat. The scope for this will include adding a sound proof drop ceiling below the HVAC system, adding a table and chairs, cubbies, etc. as can be afforded.

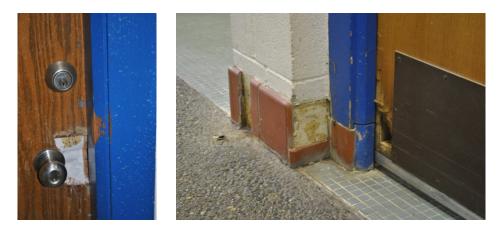
- 34. This item will only be done if the enclosure happens. This would happen so that a large family changing room (with shower) can be completed.
- 35. These will be replaced using the operational Repairs and Maintenance budget and be replaced as needed.
